# Todmordenen Bandstand

Design and Access Statement  
April 2024

Project name: Todmorden Bandstand  
Project number: 9691  
Client: Todmorden Town Council

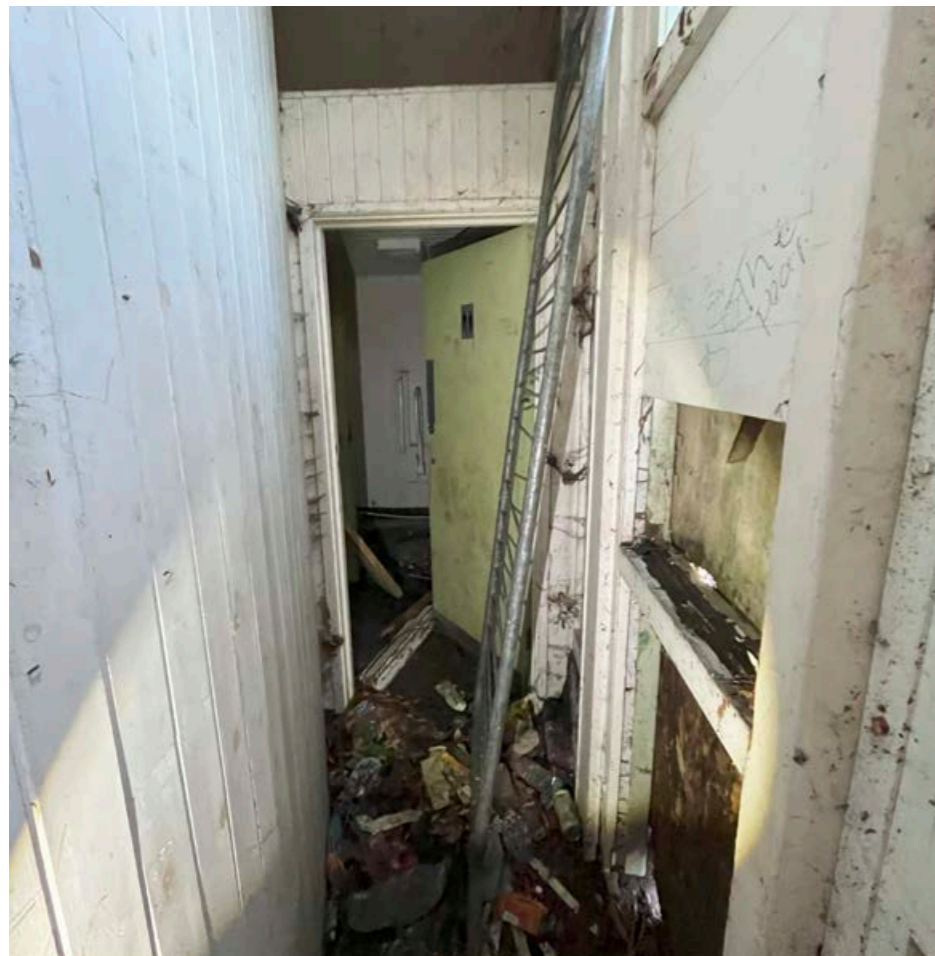
View to lobby space and WC

Water pooling on WC floor and damage due to leaking services. Drainage requires further inspection by MEP consultant.

A new floor is required, which should carry through to the Lobby.

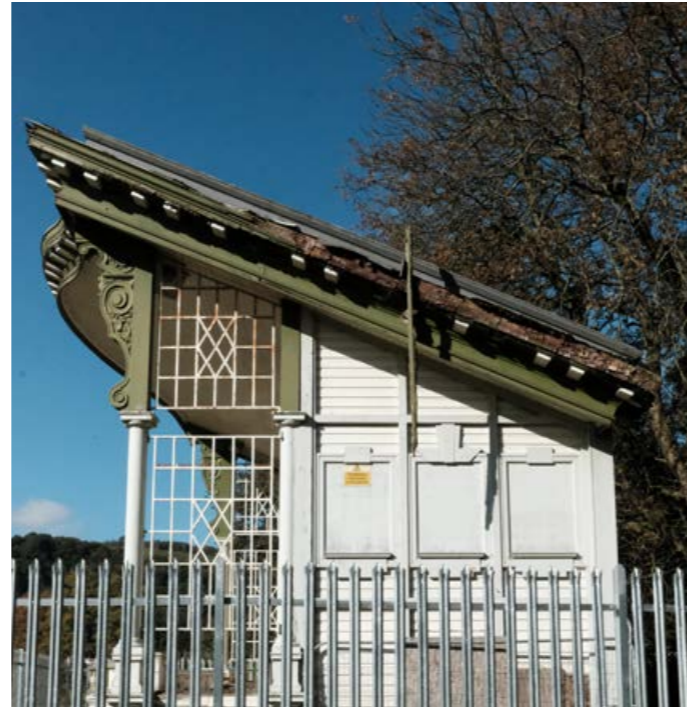
Damage and wet rot to the roof verge on the East Elevation

Extensive damage to verge, where timbers to fascia, soffit are missing, causing water ingress and wet rot.

Allow for complete replacement of damaged and missing roof timber in a suitable species of timber.

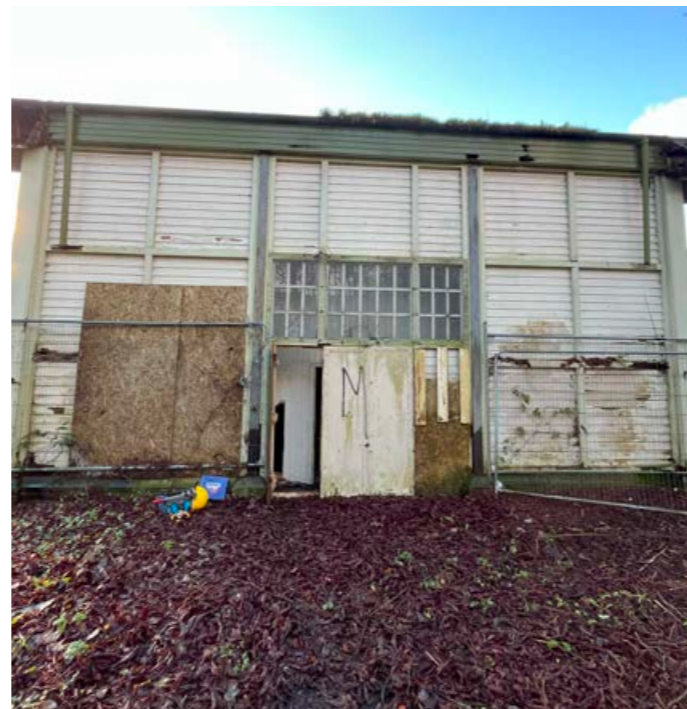
Rainwater downpipes missing and vegetation blocking gutter.

Missing sections to rainwater downpipes. Water discharging on to timber structure below. Existing rainwater goods appear to be cast iron.

Renew all rainwater goods in cast iron and install leaf guard. Increase capacity of rainwater goods to future-proof. Repair structural timbers to Structural Engineer's design following appraisal.

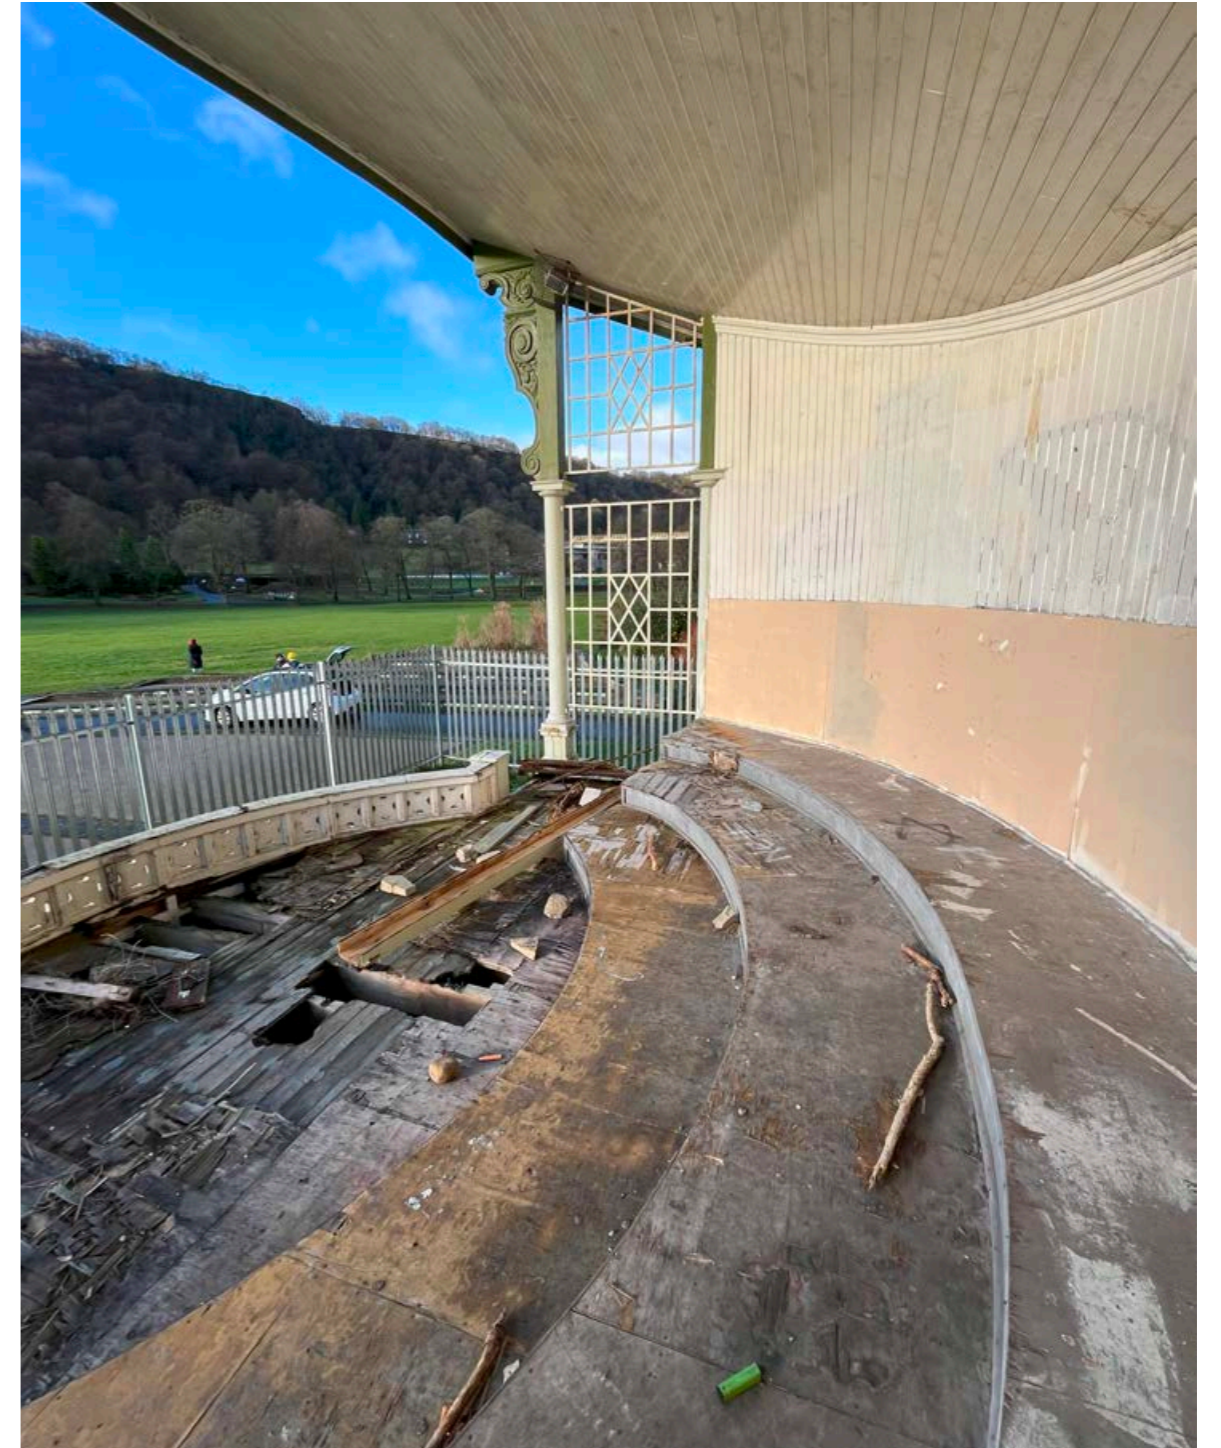
Missing and damaged stage floor boards and temporary plywood covering to stage.

Ply covering has exacerbated wet rot and deterioration to floor boards. Lower stage shows the worst deterioration, with large voids.

Removal of all ply covering. Stage requires the complete removal and replacement of all floorboards.
